# Langebros bro - renova- tion of bascule span

Registration of internal condition of counterweights by non-destructive methods.

Project name **Langebros bro, udkastet forslag til renovering af bascule span**  
Project no. **1100056833**  
Recipient **City of Copenhagen**  
Document type **Memo**  
Version **0.5.0**  
Date **2024-03-20**  
Prepared by **BL**  
Controlled by **CLP**  
Approved by **BL**

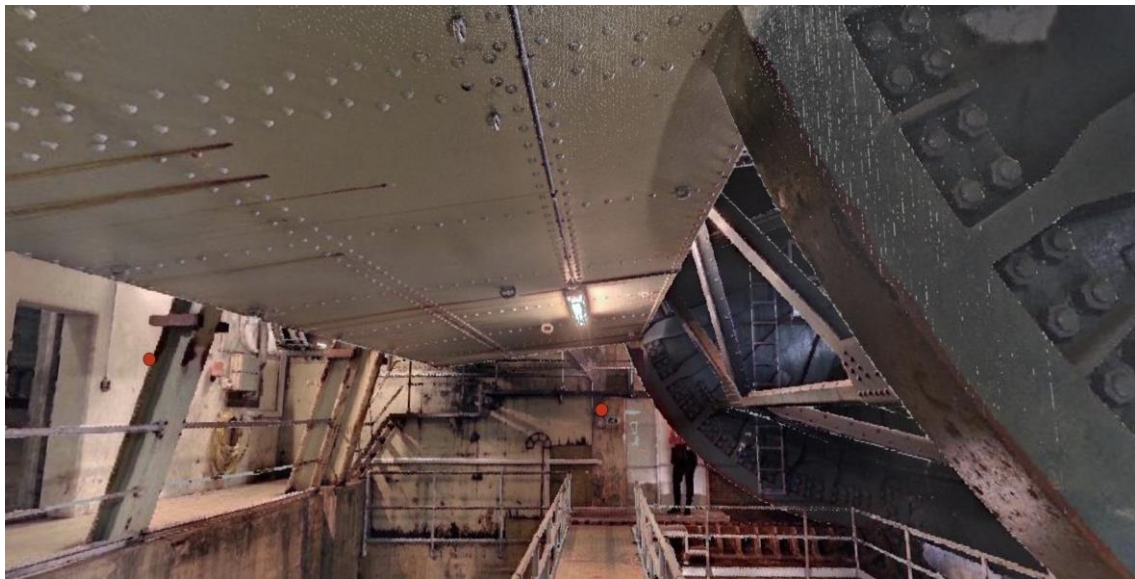
**Figure 6 Photo, underside of the fixed counterweight. The rows of rivets lengthwise and crosswise show the location of internal steel bulkheads.**
