VINTERBAD BRYGGEN

REVIDERET SKITSEFORSLAG

2013-01-29

Vinterbad Bryggen is a winter bathing club with 600 members, though without facilities. They have now found a location at Islands Brygge in the southern extension of Copenhagen Harbour Bath. BIG architects were asked to develop a proposal for the facilities which should include 3 saunas, a wellness room, a basin, changing rooms and a social space for the growing amount of members.

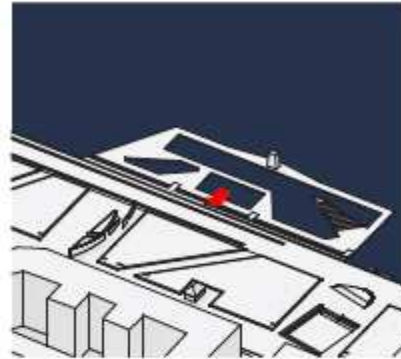
A MOAT AS SAFETY

We now suggest that other safety strategies are investigated such as creating a buffer zone between the harbour and the bath that makes it inaccessible when closed. This could be achieved either by shortening the access stair and ramps and/or moving the bath as far from land as possible considering the position of the piles.

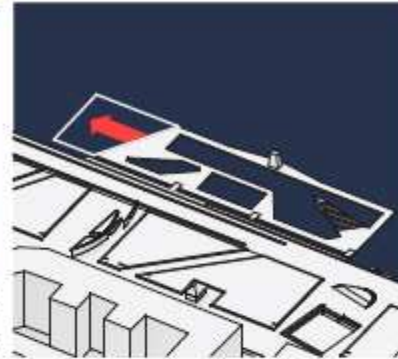
EXTENSION TO THE SOUTHWEST

The harbour bath is extended towards southwest and is finished as a complete rectangle.

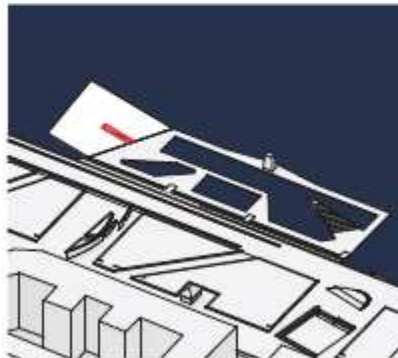
THE ENTRANCE

The entrance is a cut into the platform in the extension of the central walkway on the harbour bath which creates a long central axis as in the traditional winter baths

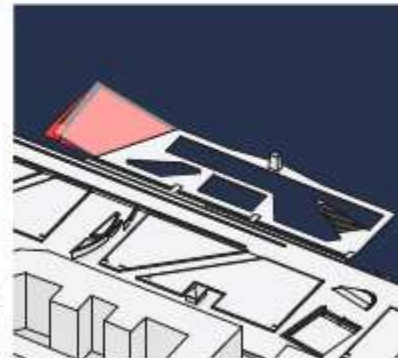
THE WINTER BATH FACILITIES

The winter bath facilities are placed under the wooden deck facing southwest. A terrace surrounds the entire building. During the dark seasons the winter bath becomes a lantern reflecting in the icy water visible from Islands Brygge as well as Kalkved Brygge.

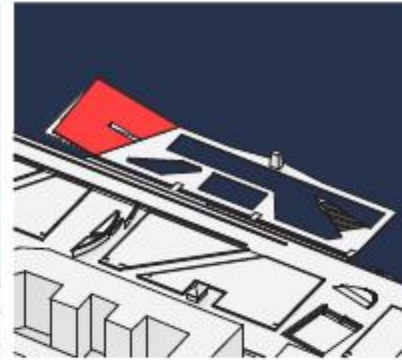
WOODEN ROOF AND CEILING

As an extension of the harbour bath the roof as well as ceiling is covered by pine (fir) wood planks, the direction of the planks follows the steps on the roof surface.

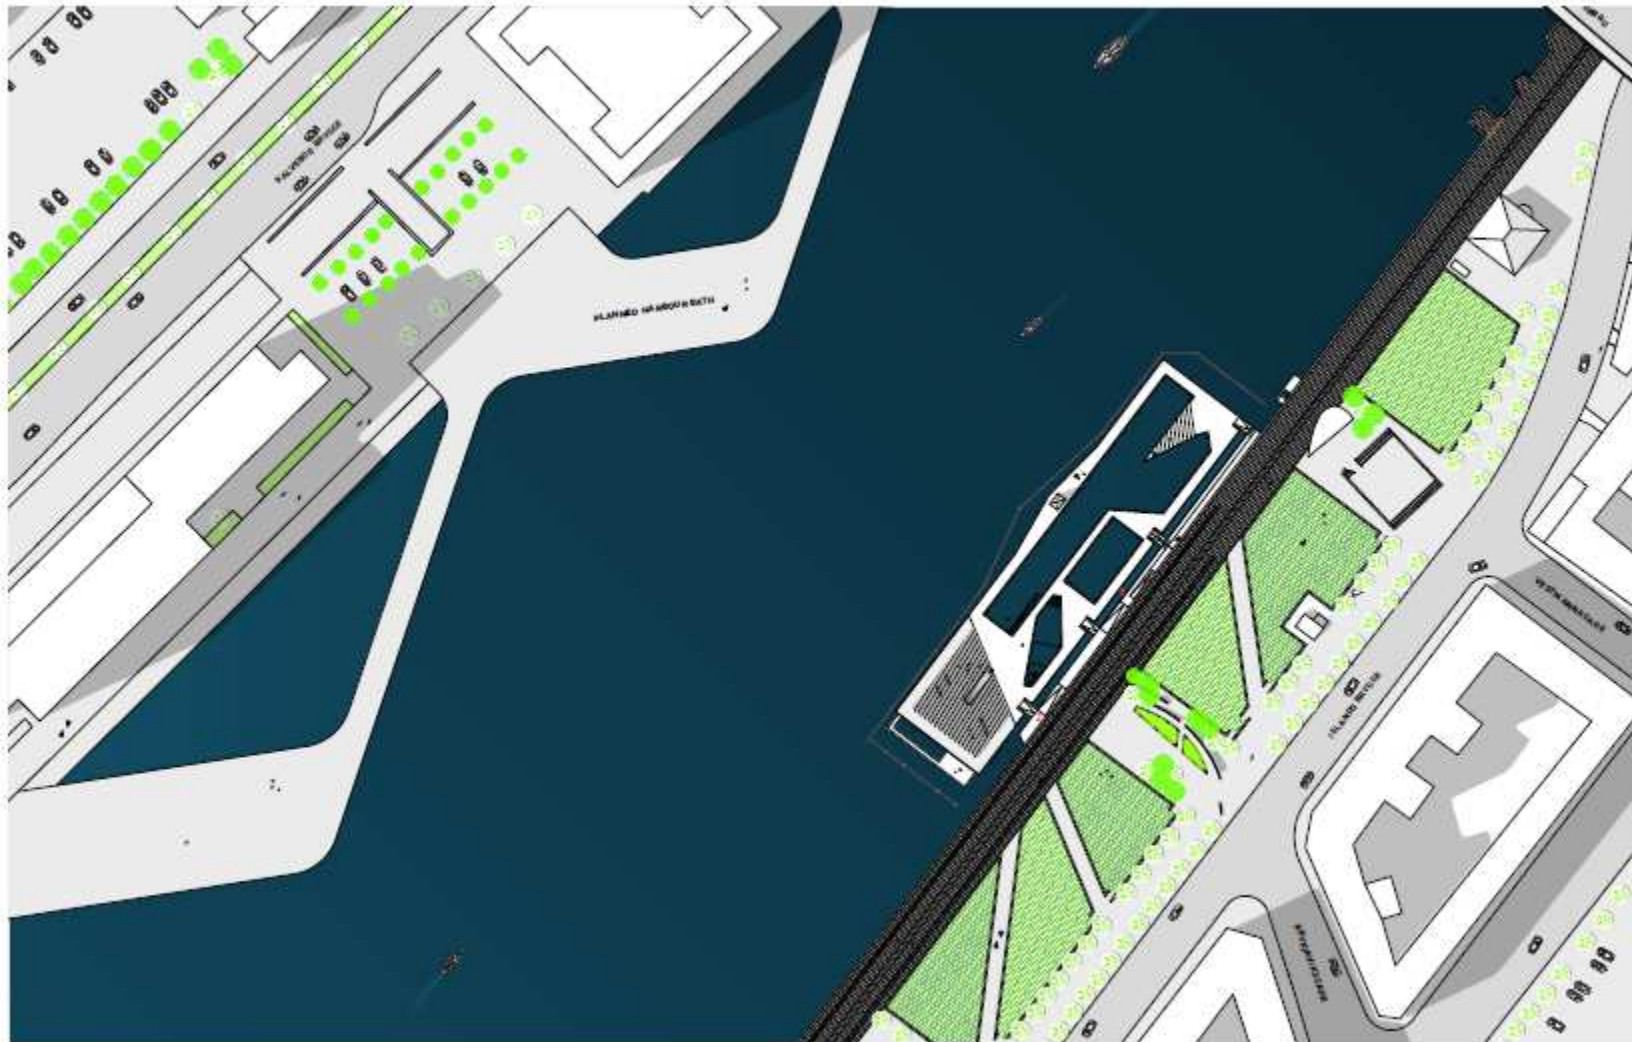
1. A buffer zone between the harbour and the bath which makes it inaccessible when closed is achieved by shortening the access stair and ramps. A moat between the bath and the access area is created.

2. To give access to the winter bath via ramps we propose to relocate and extend the ramps to achieve the required inclination and keep distance to new roof terrace of the winter bath. The solution should be studied further.
