# Strandlodsvej Portal Study

## Noise report

| <b>Projekt</b> | Metroselskabet Lergravsparken |
| <b>Dokumentnr.</b> | N2.034.26 |

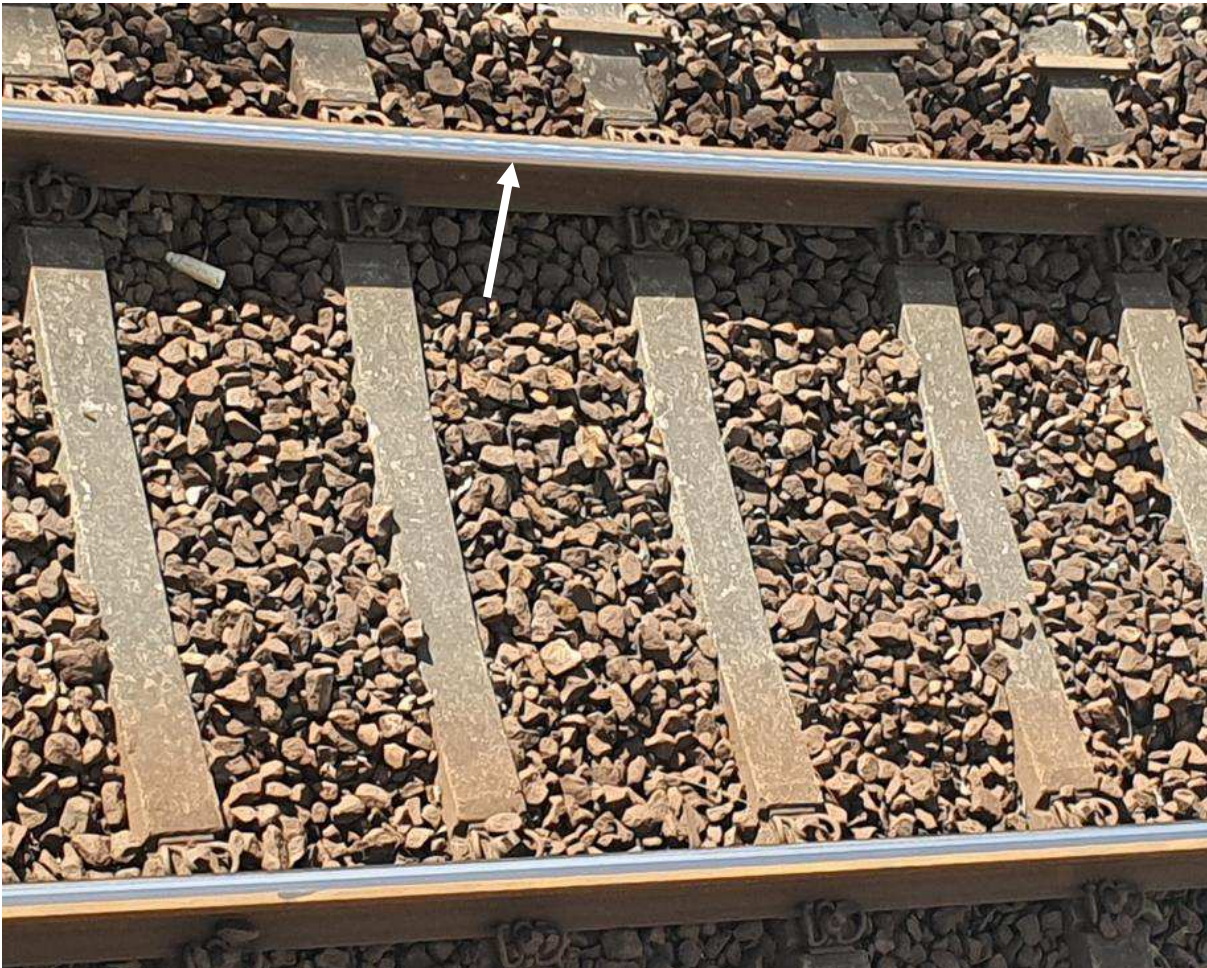
Figure 4 shows northern track in the curve, where corrugations on the surface are clearly visible on the rail head of the inner rail. The wavelength is estimated to be 6–7 cm based on a 60 cm sleeper distance. The outer rail has not the same wear marks.

*Figure 4 – Corrugation on the rail head of the inner rail in the northbound track because of stick-slip behavior*

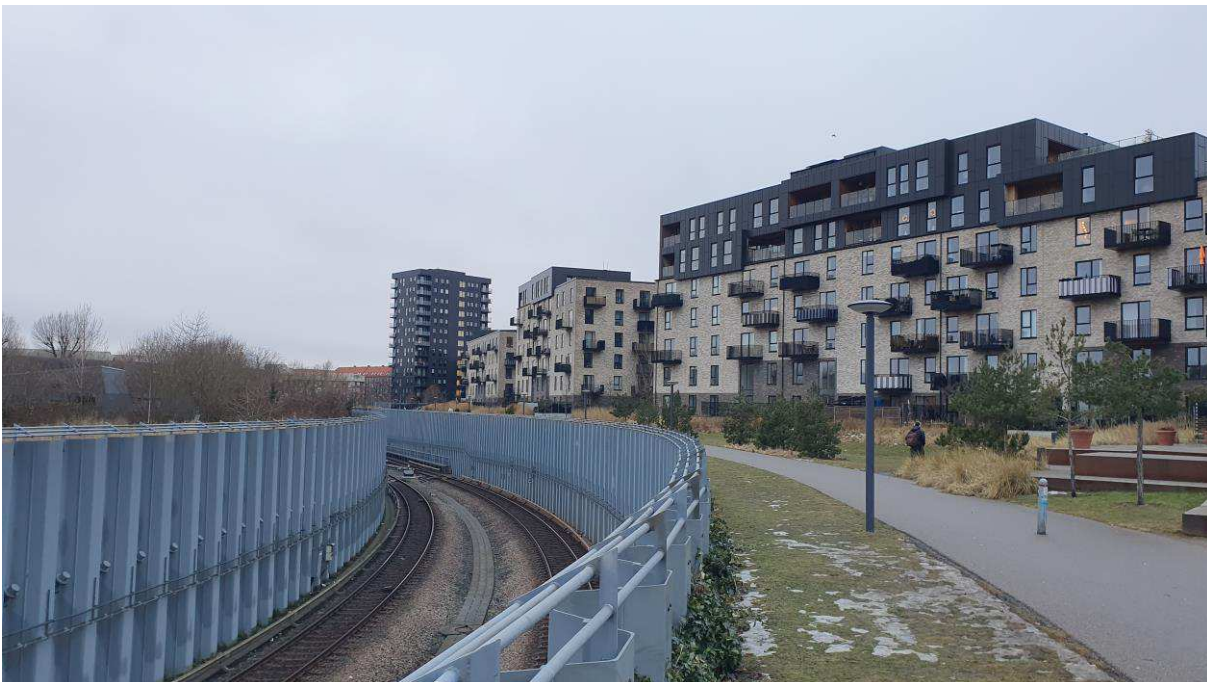
*Figure 5 – Current situation. Open railway cutting with sheet-pile walls. Residential buildings north of the railway cutting.*

The sheet-pile walls extend approximately 1 m above the surrounding terrain. North of the trough, the nearest buildings consist of 5–7-storey residential buildings. From the upper floors, there is unobstructed line of sight to the tracks. The shortest horizontal distance between the residential buildings and the railway cutting is approximately 16 m.
