# Strandlodsvej Portal Study

## Noise report

| <b>Projekt</b> | Metroselskabet Lergravsparken |
| <b>Dokumentnr.</b> | N2.034.26 |

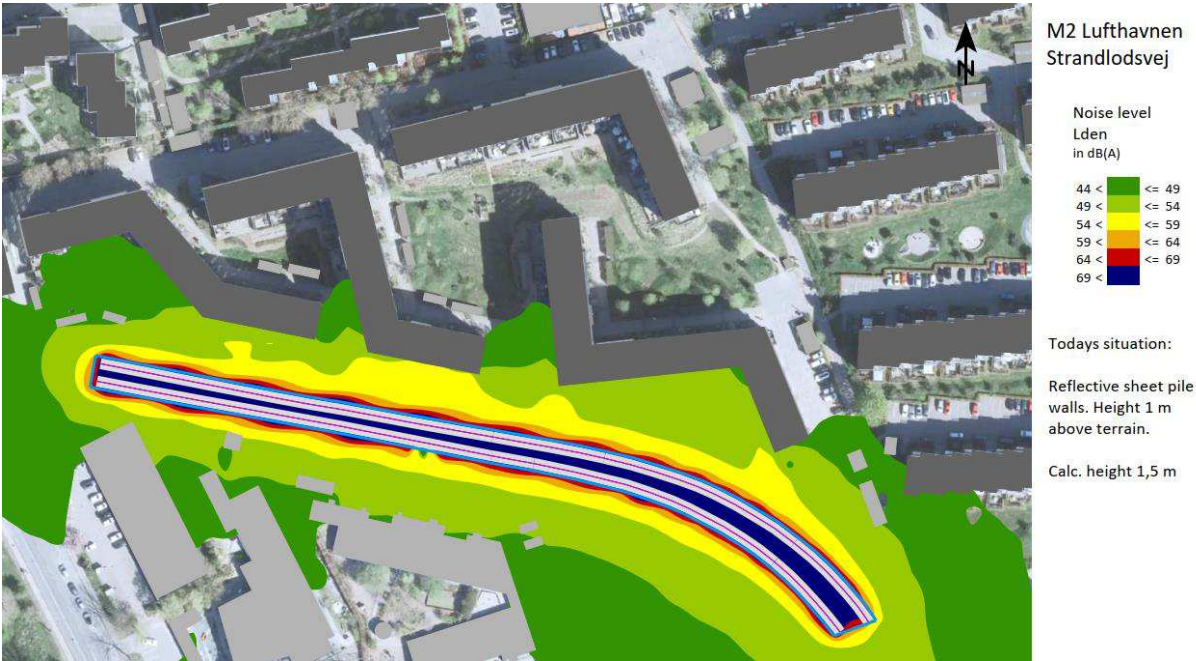
In addition, calculations of noise propagation on both sides of the trough have been carried out at a standard height of 1.5 m above ground level, in order to assess the impact and attenuation on outdoor recreational areas at ground level.

Figure 8 – Current situation. Noise propagation at ground-level height (1.5 m)
